Retrofit of a semi-detached house from the 50's towards passive house standard.

## **Semi-detached house in De Pinte, Belgium**

**IEA – SHC Task 37**

**Advanced Housing Renovation with Solar & Conservation**

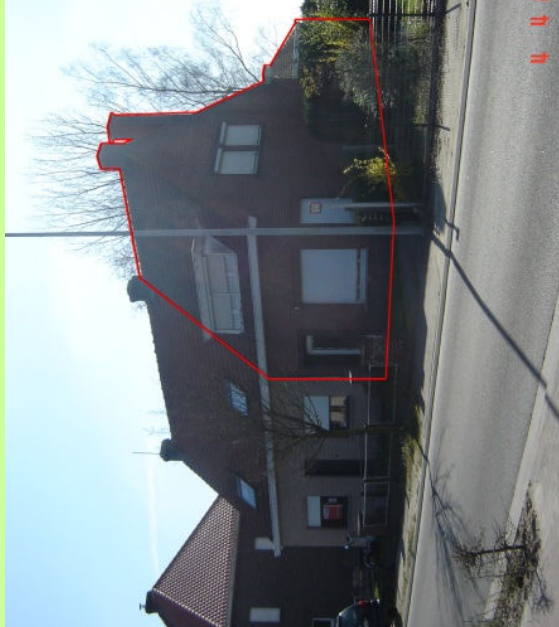
The original front view of the dwelling

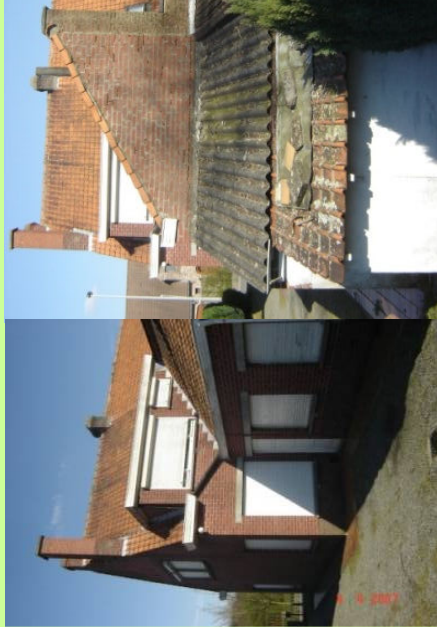
The original back view of the dwelling

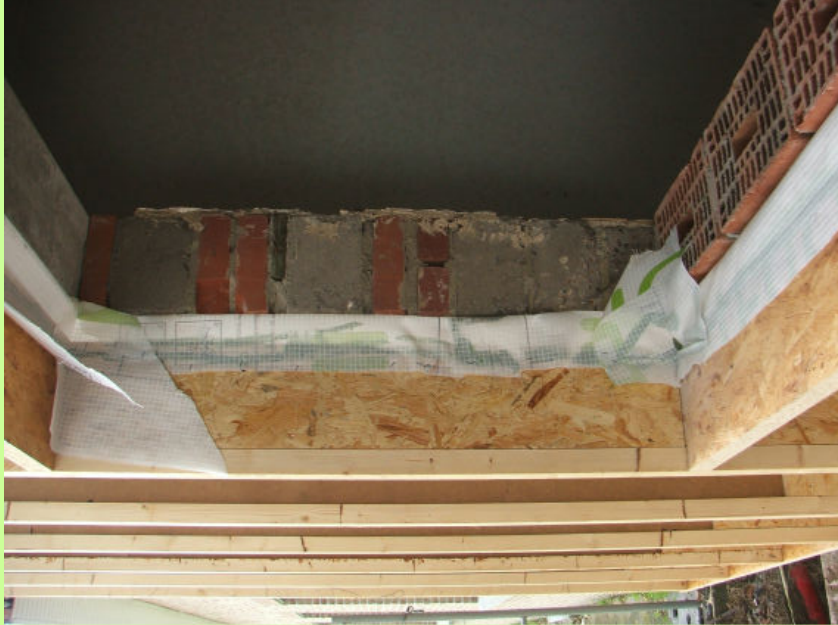
Timber frame construction fixed to the existing wall. The originally wall was erected with concrete blocks, but during the retrofit and the adaptation of the windows some clay tile blocks were build in.

The old house was built with a traditional cavity wall construction, without insulation. After consultation with the contractor, the outside wall was removed, to be replaced by a timber frame construction fixed to the inner walls, containing the insulation layer.

During construction, it became clear that the inner wall was far from straight. In some places a difference of 7 cm had to be gapped.

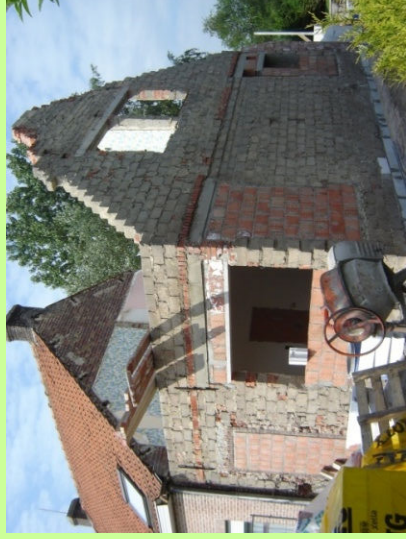
The house after dismantling the walls

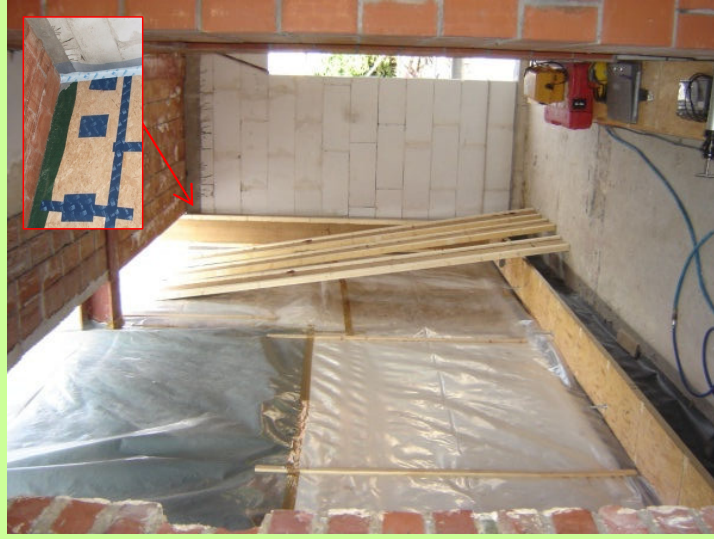
The construction of the common wall

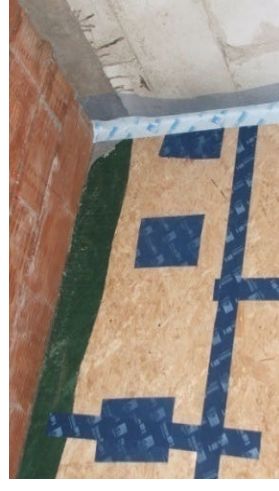
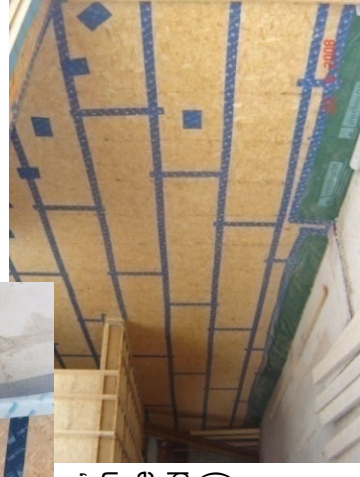
Taping off the OSB boards, and connection between OSB and plaster on the brick walls (the white band in the upper photo)

Because of the mixed structure of solid and timber construction, the connections between them were critical points. Special bands that can be plastered were used to make this connection.

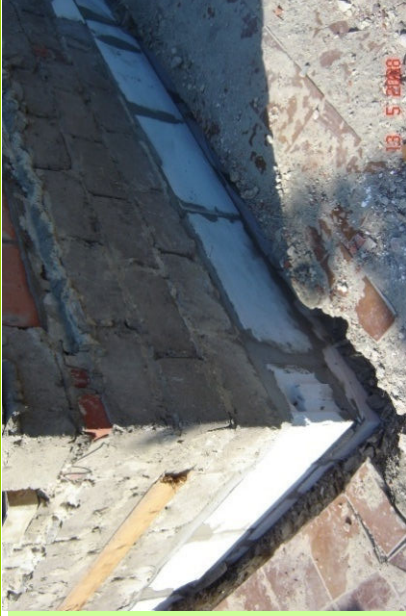
Thermal break at the base of the walls

A classic thermal bridge when retrofitting is the base of the wall. Calculations showed its' great impact. Because a moisture resisting barrier had to be installed anyway, it was decided to replace the first layer of bricks by cellular concrete.

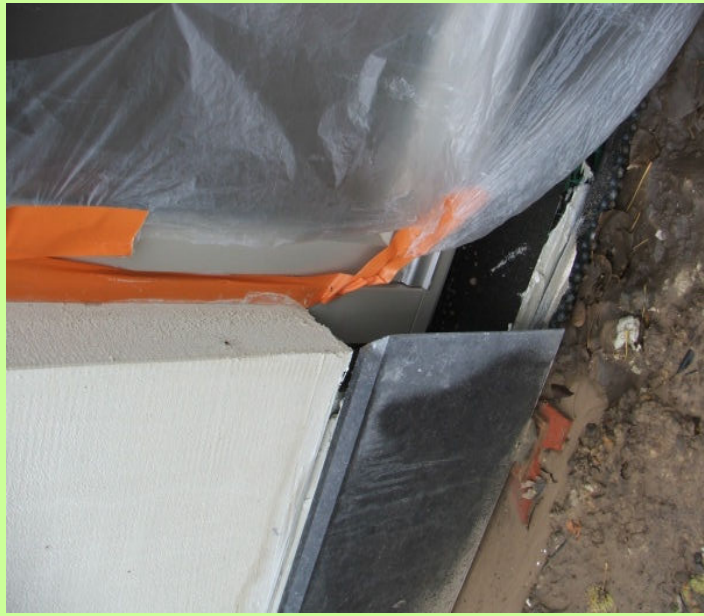
Connection threshold with front floor.

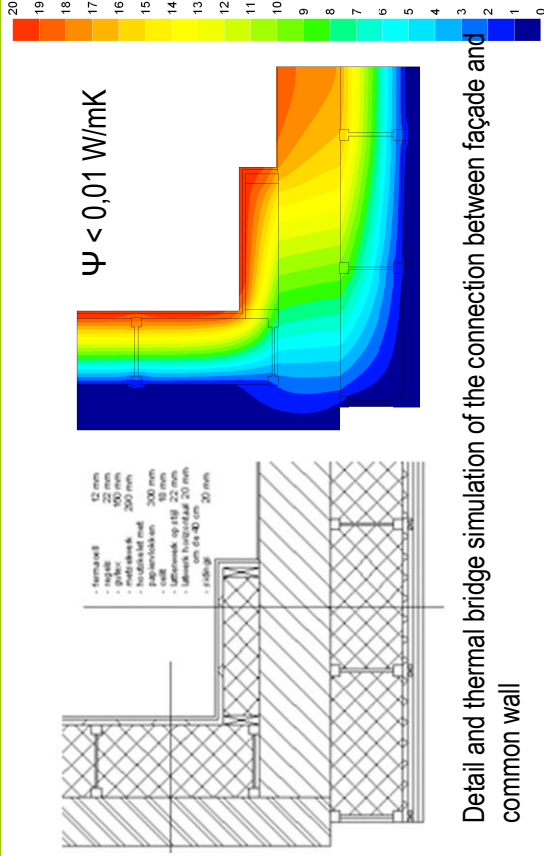
Detail and thermal bridge simulation of the connection between façade and common wall

The joint between façade and common wall was another problematic connection. Here, no real solution was found, but adding an additional insulation layer on the inner wall at least greatly reduced the thermal bridging effect.

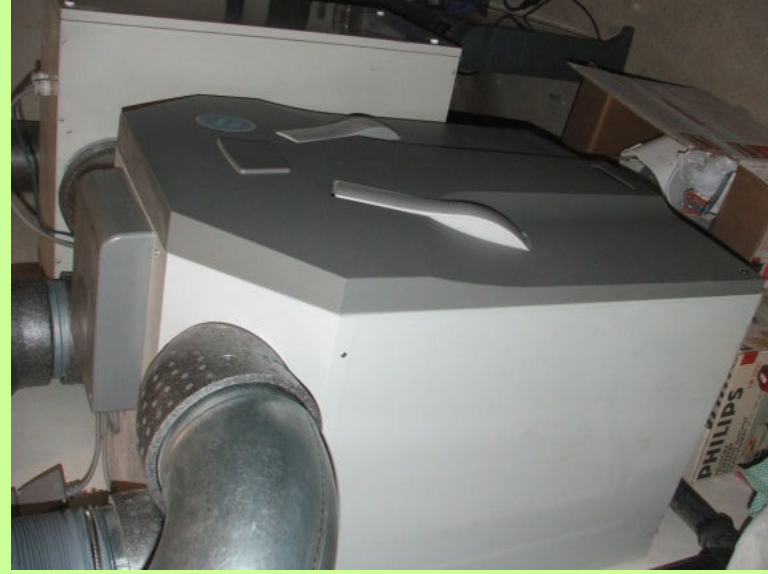
Mechanical ventilation unit.

Mechanical ventilation system with a counter flow heat exchanger ( $\eta=84\%$ ).

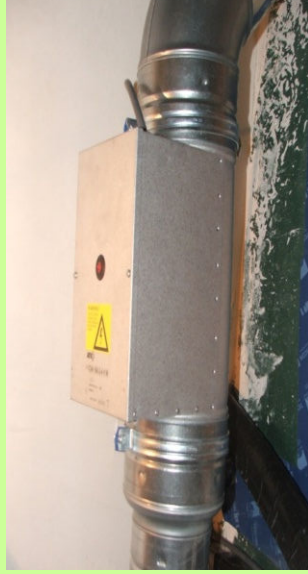
An electrical resistance for post heating the living areas.

An electrical decentral post-heater (1200W) warms the ventilation air going to the living room. Additional electric heaters can heat the air going to the bedrooms as desired. In the bathroom an extra electrical heater is installed because of the higher comfort temperatures that are required there.

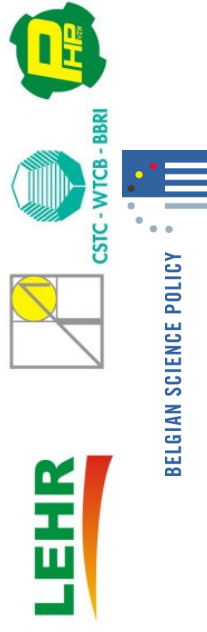
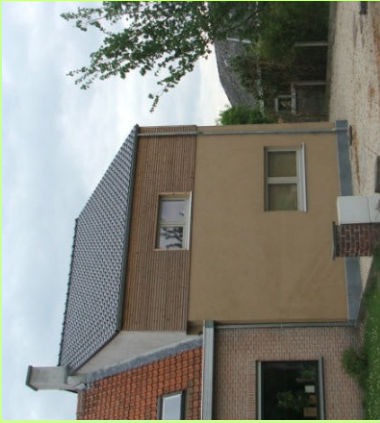
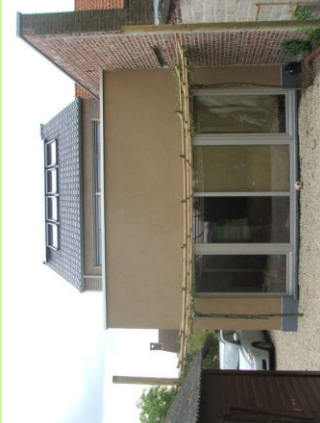
Front and rear view of the house; trees for natural shading

To prevent overheating during the summer, screens are installed on all roof windows, as well as on the back windows on the first floor. 2 trees in front of the windows will provide sufficient shadow on the ground floor.
